PANDROL

VERSE® TECHNICAL INFORMATION PACK

PREVENTING BUCKLES & BREAKS

002
04th July 2019

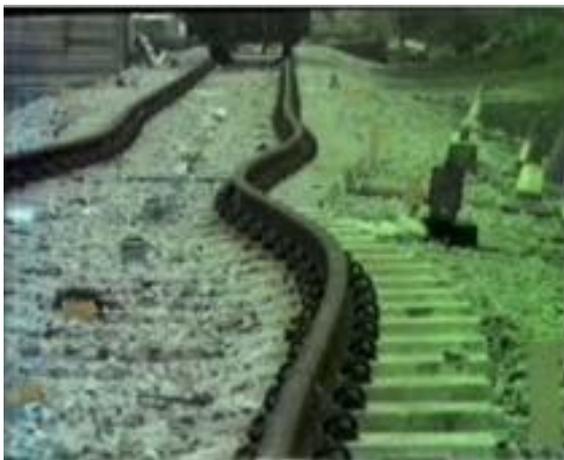
(Track buckle)

If the track geometry is in excellent condition, along with the fasteners, sleepers and ballast then the rail will have nowhere to go and will not buckle until there are very high stresses. However, the slightest loss of straightness will result in the track buckling. The vibration of an approaching train can trigger this. The pent up stresses are such

that the sideways movement can be more than a metre as the rail wants to reach its stress-free length. If the ballast shoulders are in poor condition the lateral stability of the track is low and the buckle will be horizontal.

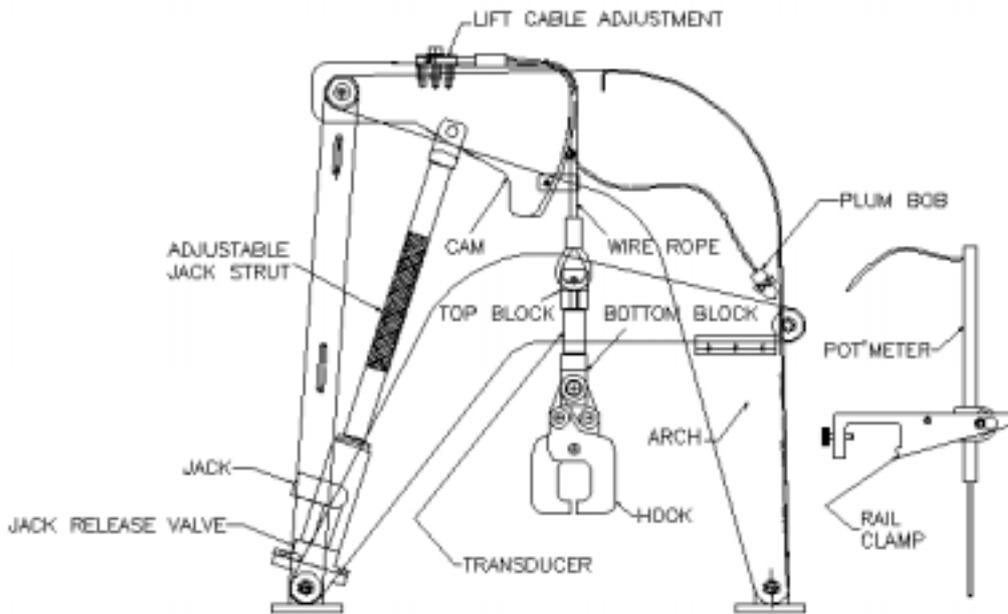
(Schematic Drawing of the **VERSE®** Hardware)

VERSE® is a non-destructive method that can be completed quickly and at less

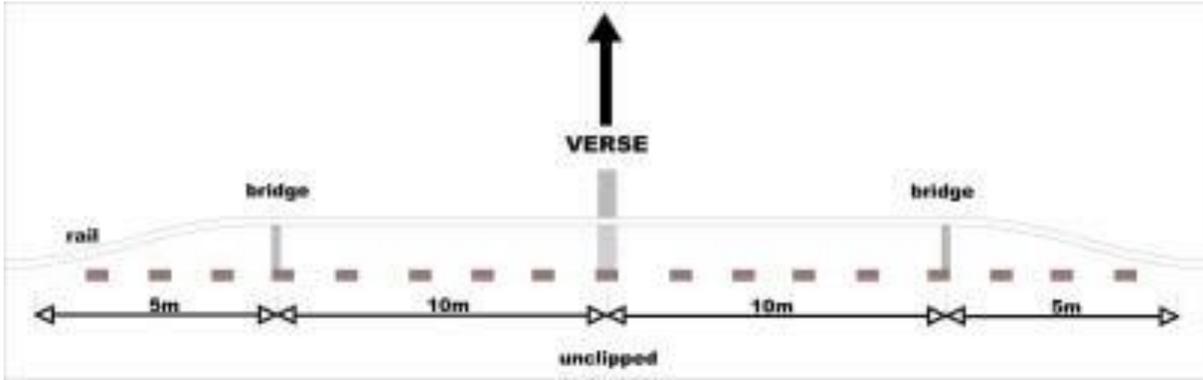
(SFT Measurement with **VERSE®**)

Firstly, the rail must be at a temperature lower than its SFT so that the rail is in tension. Taking a measurement requires around thirty metres of track to be unclipped which is normally done by two persons whilst another one sets up the **VERSE®** frame which sits on the sleeper and straddles the rail.

VERSE® incorporates a clamp to the rail head which allows the rail to be lifted with its built-in hydraulic jack. A measurement entails lifting the rail to 10 kN (monitored by a load transducer) and logging the load and displacement monitored by a displacement transducer at regular increments. The output from both transducers are routed via a dedicated signal condition system to a hand held computer.

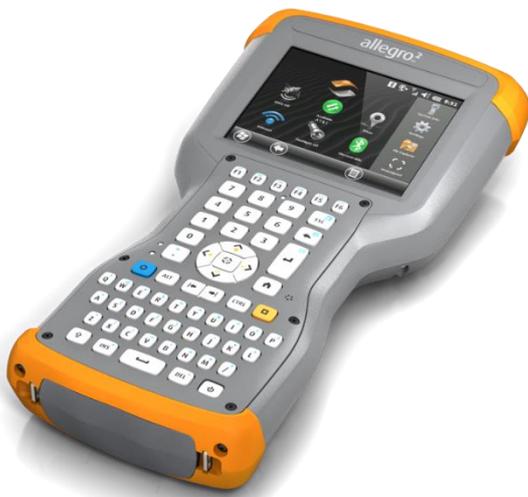
The handheld computer steps users through the measurement process with critical data being inputted by the user. It then guides the user through the rail deflection process and returns an instant SFT result trackside together with an evaluation of data quality. The lift data files can be stored on the handheld and transferred to a PC to be analysed and stored in the office space.

(Hand Held Computer)

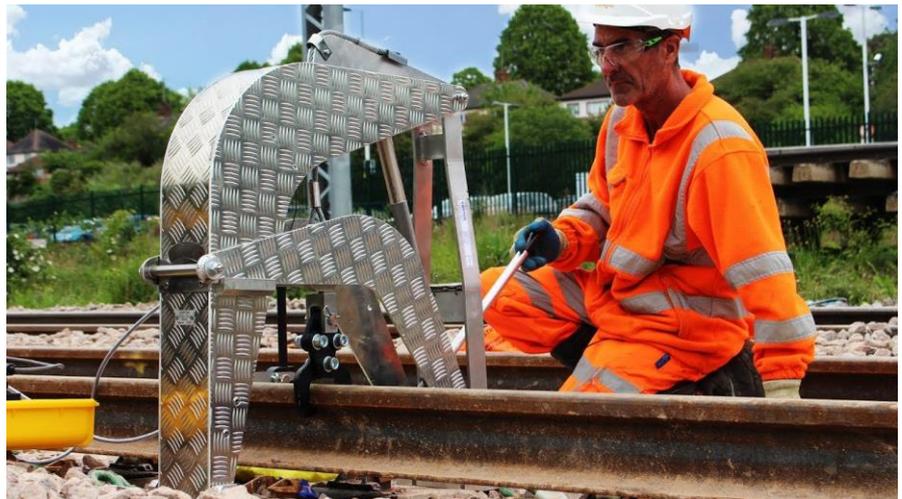
(**VERSE®** Measurement)

Along with some other data such as ambient rail temperature, rail profile (a simple selection from a software menu) and height of the rail, the handheld software produces the SFT result. The height of the rail is included to take account of rail head wear and rail grinding which will naturally affect the stiffness of the rail. Typical testing time will be 20 to 30 minutes for an experienced crew depending on the type of rail fastening. Downloading the site data sometime later to the PC software will allow further analysis of the data and enable the results to be added to the **VERSE®** database.

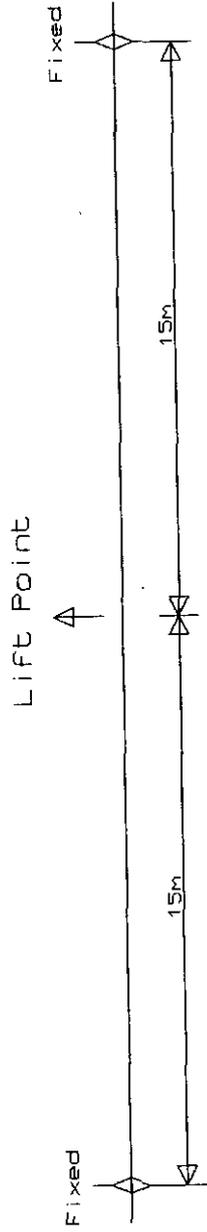
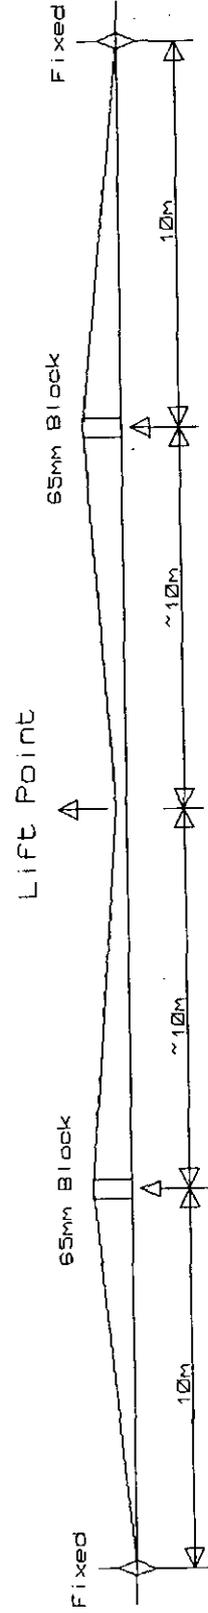
Figure 1: Rail Set-Up for VERSE Measurements

The original VERSE[®] procedure involved unclipping 30m of rail and lifting the rail from its unclipped position. Problems were encountered during attempts to measure rails on tight radius curves and baseplated track. It was found that in these cases unknown frictional forces were introduced to the rail being lifted as a result of the contact between the rail foot tip and the fastenings. Further problems were encountered where the sleepers supporting the rail were voided. This resulted in unpredicted increases in the length and mass of the rail being lifted. All of these events degraded the accuracy of the VERSE[®] SFT estimate.

The new VERSE[®] method comprises unclipping 40m of rail, jacking the rail up and inserting 65mm packing pieces at a nominal span of 20m. The rail at either end of the supported span is unclipped to give a nominal equal length of approximately 10m. Originally, the method was tried with unclipped end lengths of 5m. However, it was found that this resulted in the sleepers adjacent to the unclipped length being lifted. The VERSE[®] frame is then positioned so that it is at the centre of the supported span, the packing pieces being adjusted over the width of the sleeper so that each half of the supported span is equal in length. Figure 1 shows a schematic diagram of the rail set-up for a VERSE[®] measurement. The procedure then follows the standard VERSE[®] method^[1] with three scragging runs followed by three measuring runs.

Original Method

New Method

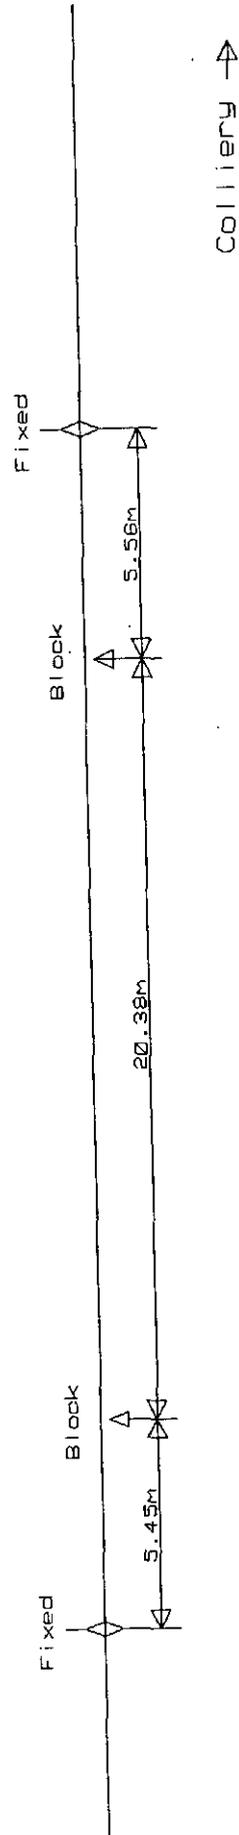
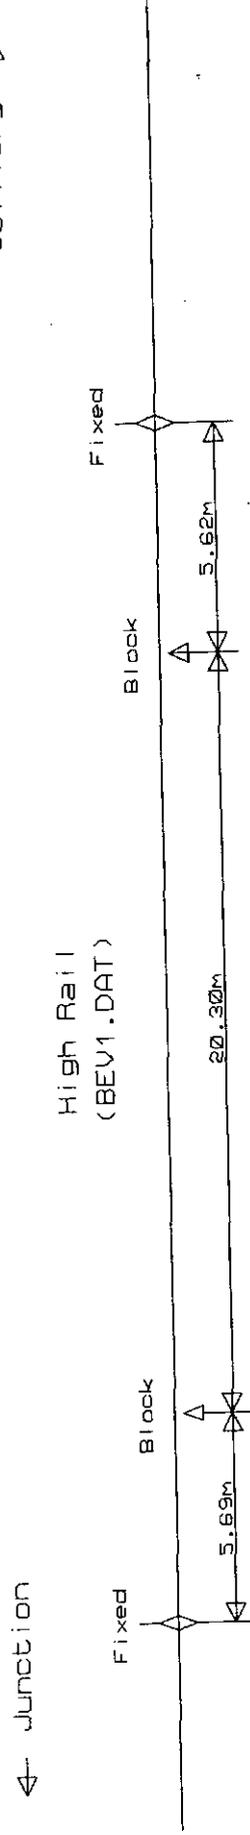
Figure 2: Bevercotes - Junction End

Two sections on the Bevercotes Branch were selected for VERSE[®] testing during the trial. The first section comprised an 86m length of CWR between two sets of breather switches on a curve of 1136m radius. The track was made up of BR98lb rail on F27 concrete sleepers with Pandrol fastenings. Both rails were measured using the new VERSE[®] method. The first measurement was carried out using the MkII VERSE[®] system, however, it was found that, due to the low stiffness of the rail section being lifted, VERSE[®] could not provide enough lift to apply the full 10 kN load. To get round this problem the measurement was repeated using the MkI system. At the point at which the maximum lift of the system was reached, a group of people stood on the lifted rail to increase the measured load to 10 kN. By adopting this method it was possible to capture acceptable load/deflection data over a load range of 0 kN -8 kN. Strain gauges were attached to the rails adjacent to the lifting position prior to carrying out the VERSE[®] measurements. On completion of the VERSE[®] measurements the strains were measured prior to and following cutting of the rail to enable a comparative measure of the SFT that was present in the rail during the VERSE[®] measurements. The data from these two measurements were named BEV1.DAT (high rail) and BEV2.DAT (low rail). The rails' SFTs were reinstated then welded up. Details of the site are shown in Figure 2.

Low Rail
(BEV2.DAT)

High Rail
(BEV1.DAT)

Rail Section BR 98lb fb
Radius of Curvature 1136m

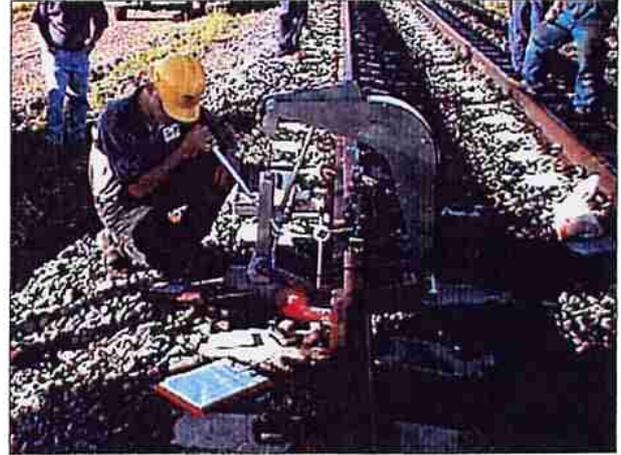
The VERSE equipment that was tested by TTCI is shown in Figure 1. The frame is fabricated from aluminum alloy with stainless steel pins at the points of rotation. The unit packs away into a box that fits into the trunk of a car.

Figure 1. VERSE Equipment in Operation

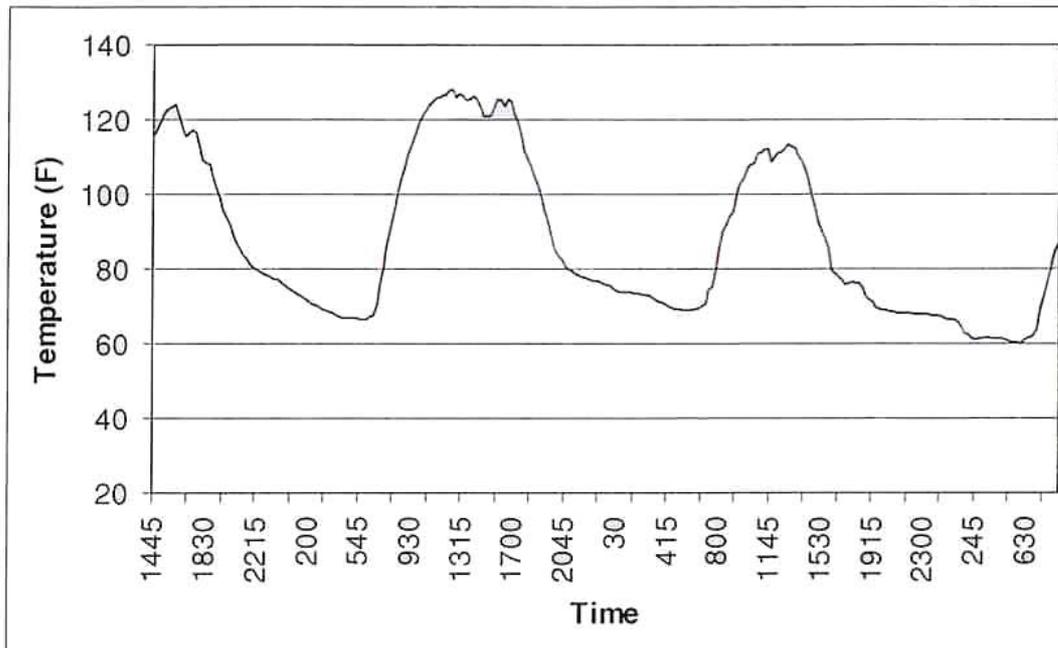
An important requirement for the test was that no rapid changes to the temperature of the rail should occur during the VERSE measurements. Figure 2 shows the rail temperature at the site for the three days prior to the tests. It can be seen that the rail temperature is most stable between 4 a.m. and 8 a.m. and between 12 p.m. and 4 p.m.. For this reason the tests were divided into two sessions, morning and afternoon. The procedures were slightly modified for the afternoon session. The differences are described in the next section.

Figure 2. Variation of Temperature, Three Days Prior to Trials

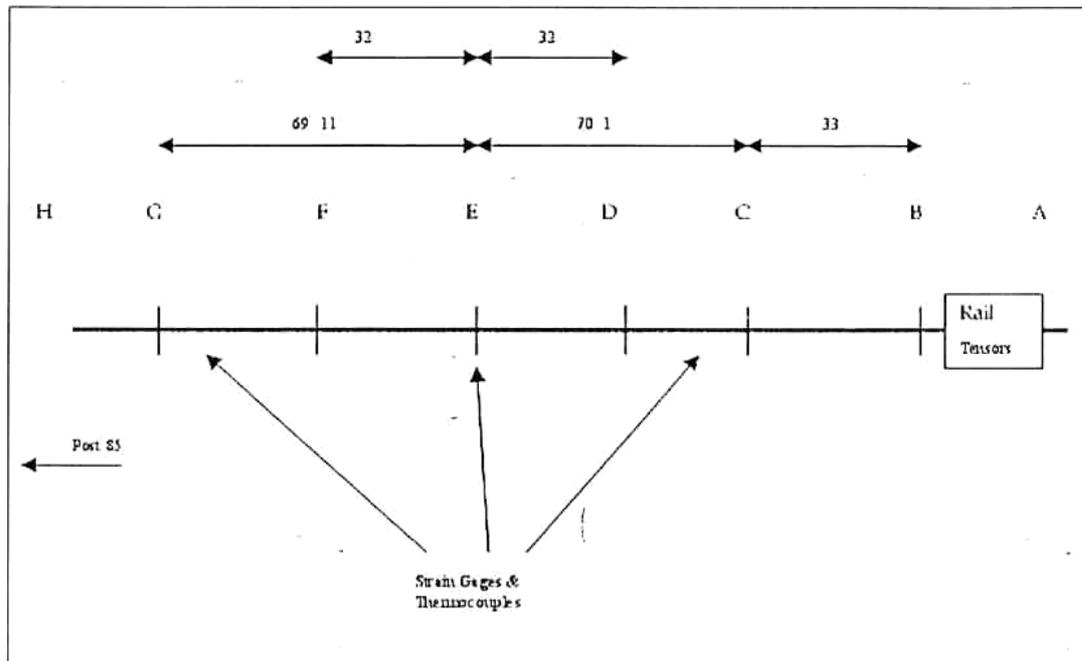
The site was measured out and marked up for the trials. Two positions (D and F in Figure 3) were marked up 32 feet either side of the VERSE lift point (E) at the center of the site. These were the positions for the rail support pieces. Two further positions (C and G) were marked up. These were the extremities of the VERSE lifted length, beyond which the rail was re-clipped after each load had been applied to the rail.

At positions A and H white paint was sprayed around the plastic insulator and the upper surface of the rail foot to provide a telltale. This would indicate if any relative movement took place between the rail and the tie once the rail was tensioned.

Figure 3. Schematic Site Diagram

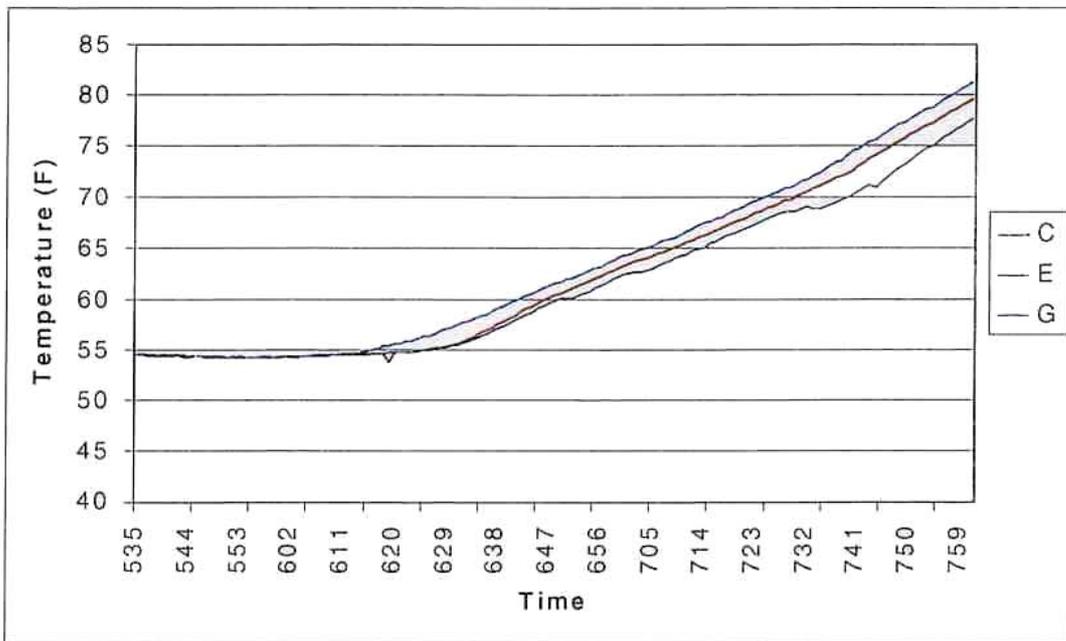
The variation of temperature over the morning and afternoon testing sessions is shown in Figures 4 and 5. It can be seen that the objective of testing while the rail temperature was stable was not achieved during the morning tests. The temperature started to rise rapidly after 6:20 a.m. This needs to be taken into account when interpreting the test results. During the afternoon session, the temperature, although high, was more stable.

The three thermocouples gave reasonably similar reading, but by the afternoon the one at location C was reading 4 degrees Fahrenheit lower than the others were.

Figure 4. Variation of Temperature during Morning Session

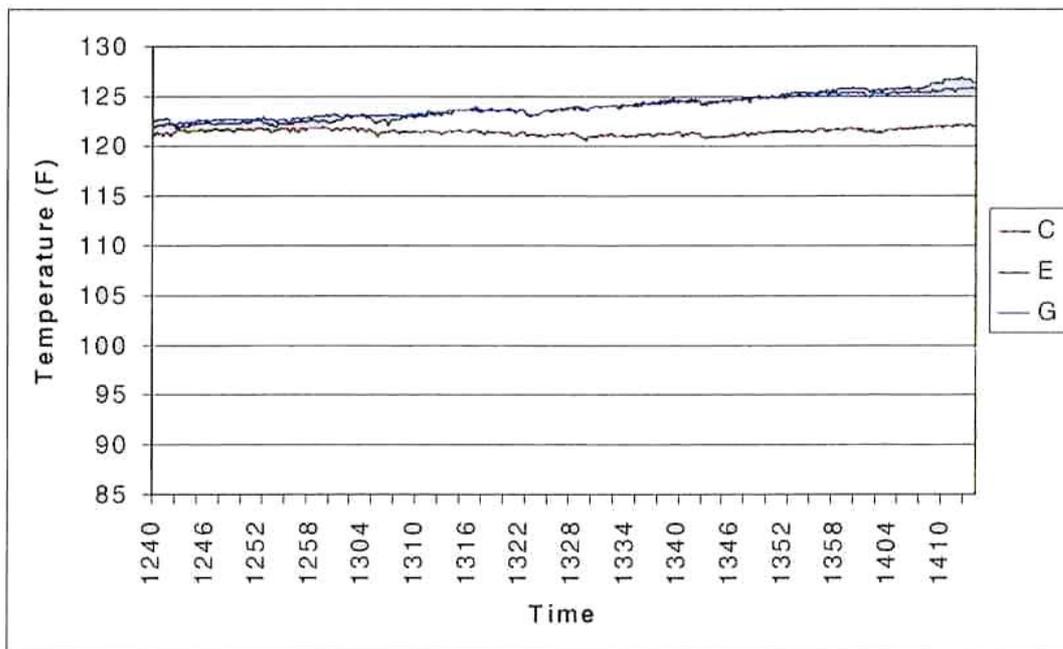
Figure 5. Variation of Temperature during Afternoon Session

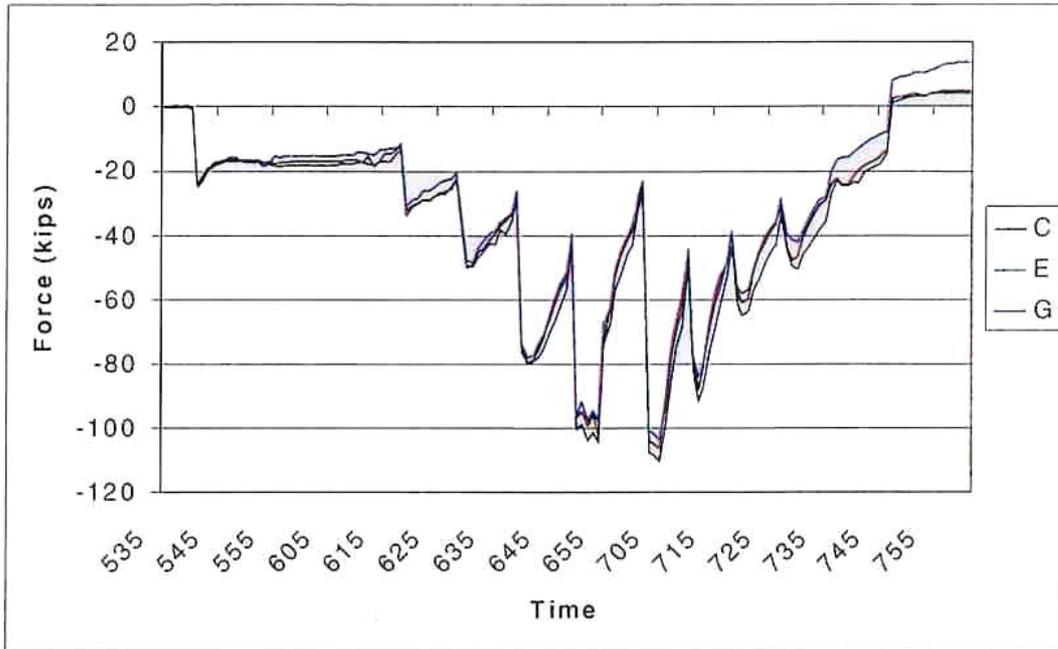
The three strain gages gave similar readings at the start of the tests, but by the afternoon the one at location G was showing a compressive offset compared to the other two. This could be attributed to the relative movement that was thought to be occurring between the ties and the ballast at this end of the site.

Figure 6. Variation of Rail Force during Morning Session

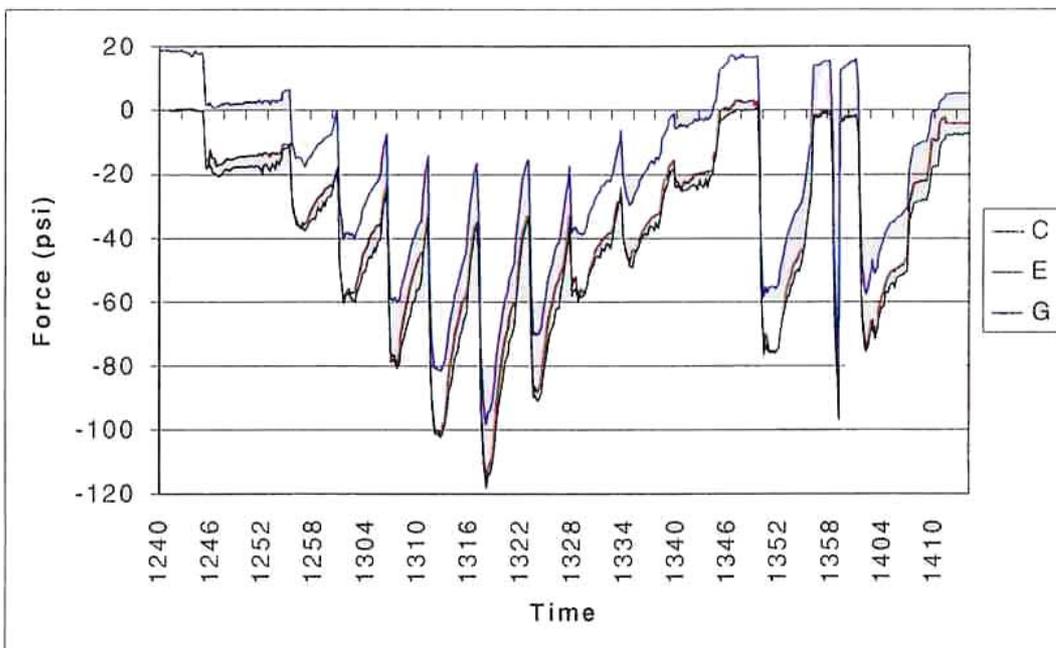
Figure 7. Variation of Rail Force during Afternoon Session

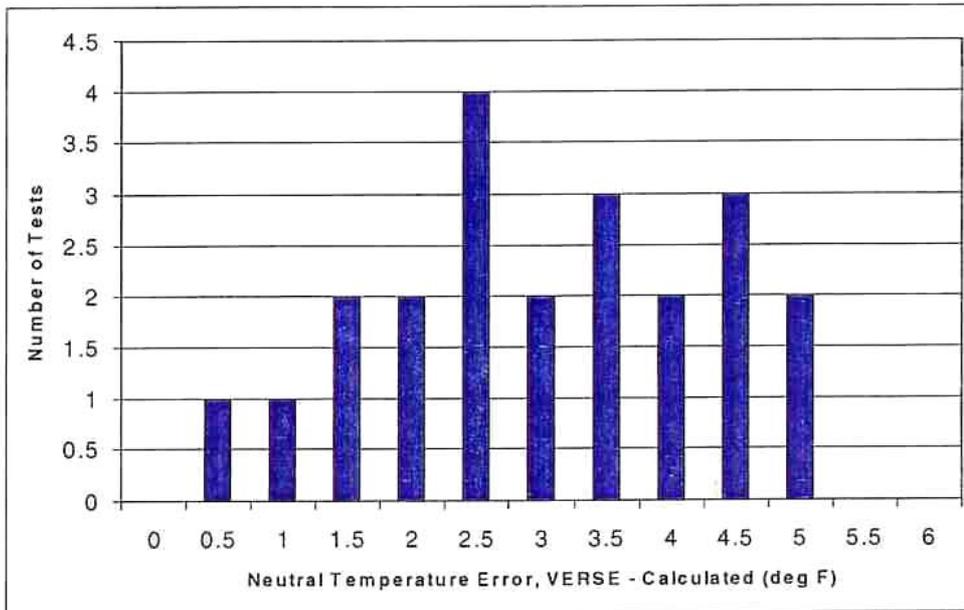
Figure 8. Distribution of VERSE Errors

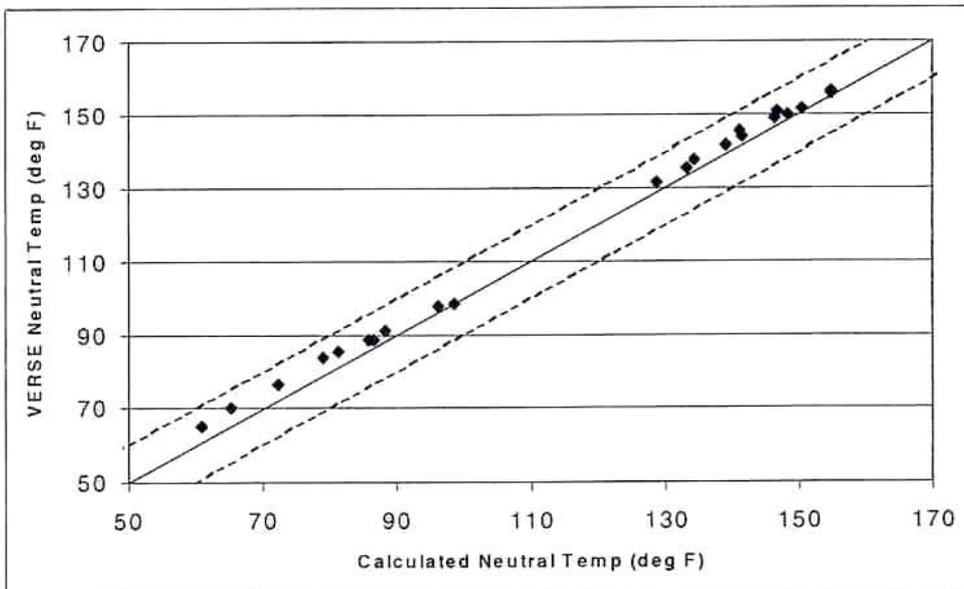
A comparison between the neutral temperature measured by VERSE and that derived from TTCI’s instrumentation is shown in Figure 9. The morning session’s results are the cluster in the lower left-hand corner. The afternoon session’s results are in the top right-hand corner. Ideally all the results should lie on the solid, diagonal line. The two dashed lines are at 10°F either side of the solid line.

Figure 9 clearly shows the bias error of approximately 3°F. All the results lie comfortably within +10°F of the calculated values. The results from the afternoon session are slightly more accurate than those from the morning session. This can be explained by the more frequent data sampling in the afternoon and the fact that the rail temperature was more stable then.

Figure 9. Neutral Temperature Comparisons

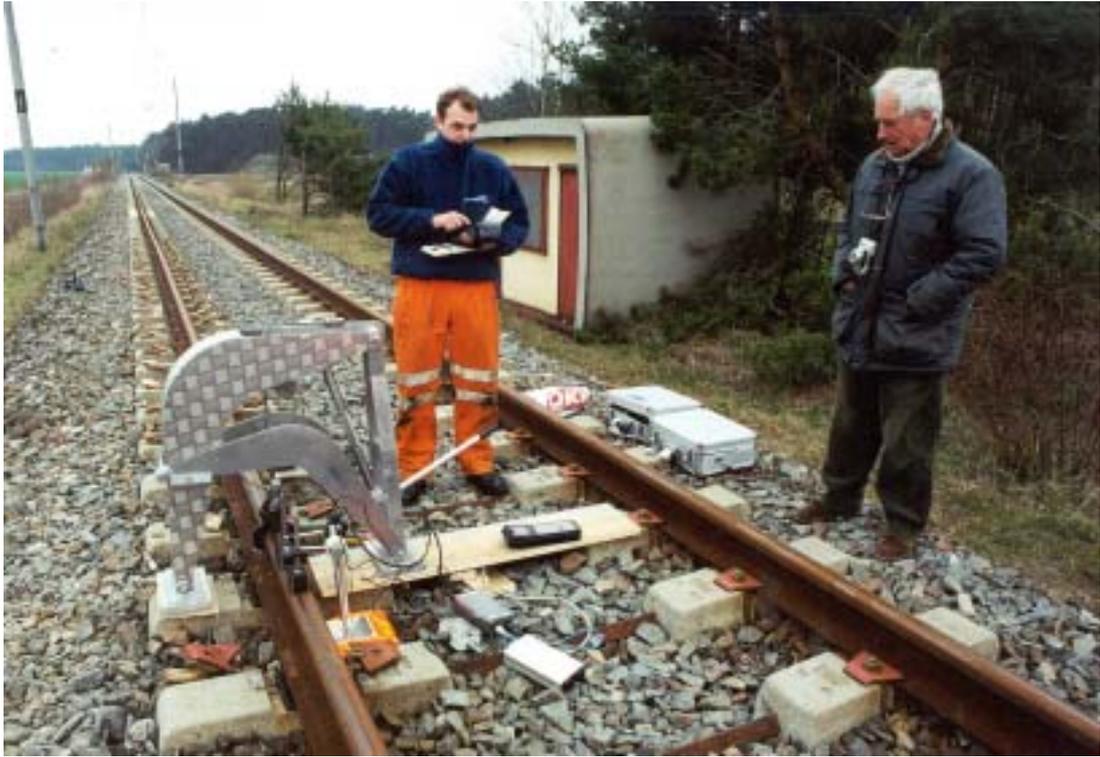
Vortok International Verse Equipment

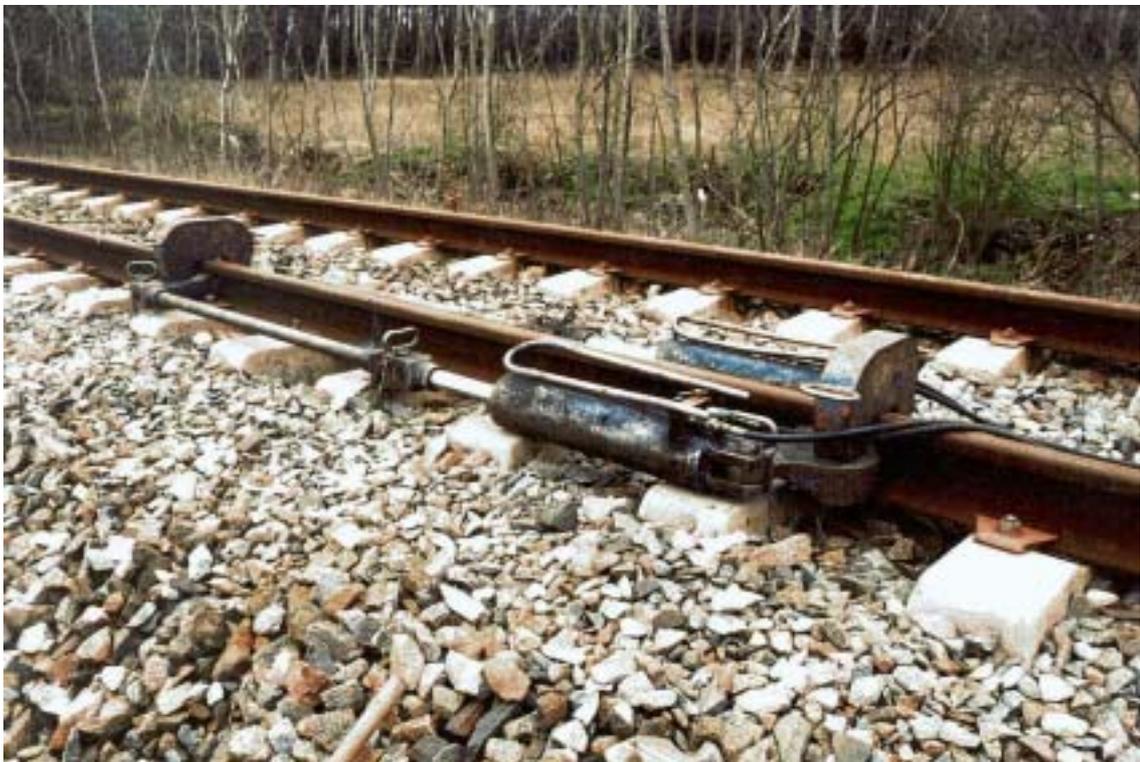
VUZ Strain Gauges

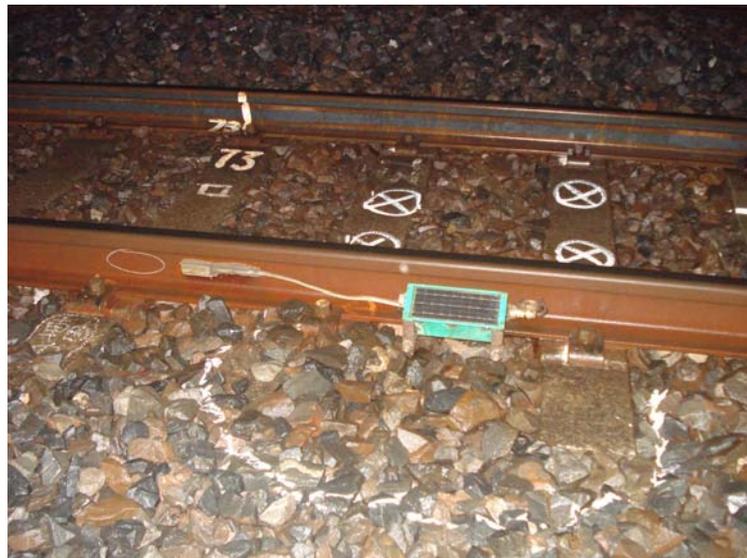
Kaneko sensor pictured above.
